SITE ASSESSMENT

**L. H. INC.
CAMBRIDGE, OHIO**

**WESTON-SPER
Technical Assistance Team
Region V**

August 1988

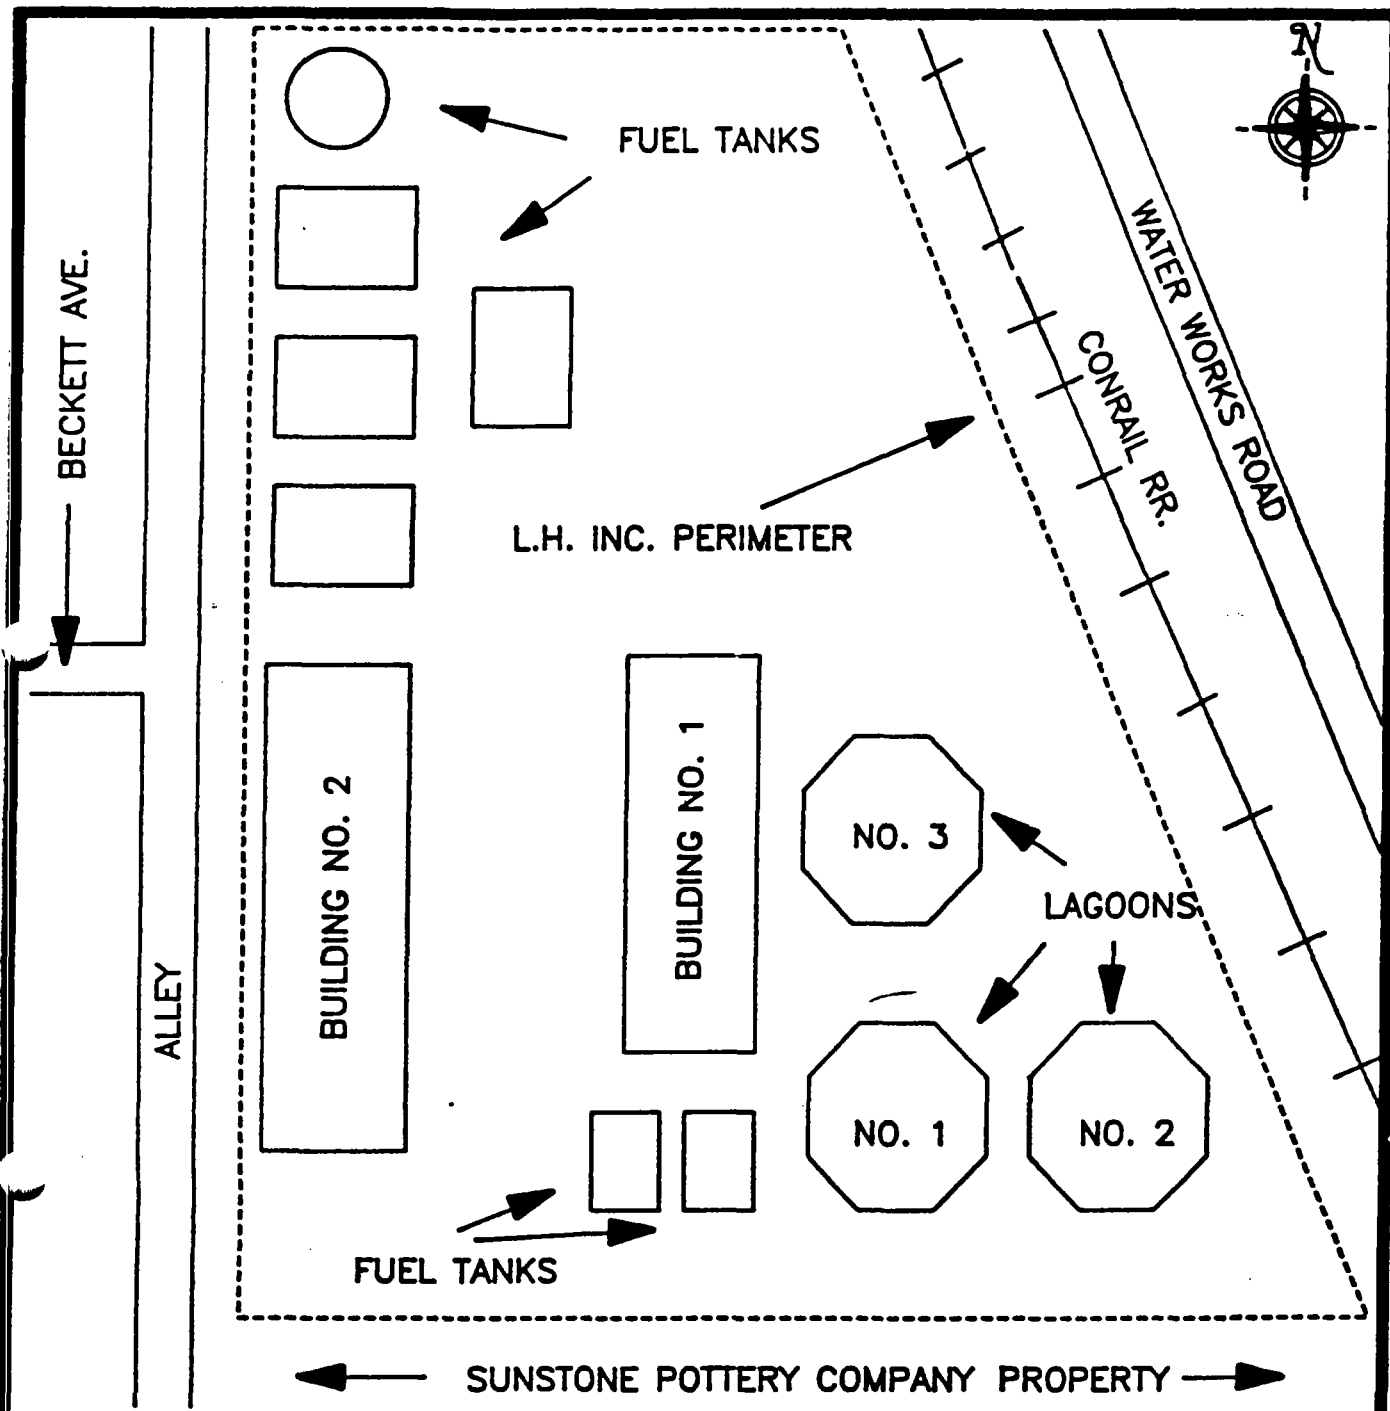
FIGURE 3
SITE MAP
L.H., INC.
CAMBRIDGE, OHIO

The 1/3-acre, abandoned pickle liquor treatment site consisted of three treatment lagoons and two brick buildings (Figure 3). A chain-link fence surrounded the site. Locked gates were located on the northwest and south sides of the site. A gate on the southeast side of the site was unlocked and provided unrestricted access to the site.

Each of the three lagoons covered an area of approximately 1,120 ft², was 5 ft in depth, and held approximately 40,000 gallons of treated waste product. A deteriorating wooden-plank fence 3 ft in height surrounded each lagoon. The lagoons were lined with thick, rubber liners to prevent leaching of treated wastes into the underlying soil. The area surrounding the lagoons was heavily vegetated with shrubs and grasses. All three lagoons contained a semi-murky liquid. Freeboard ranged from 4 to 12 inches in each lagoon.

During the site inspection, a reddish-orange sludge on the bottom of Lagoon 1 was stirred to the surface by the TAT; however, no sludge could be stirred to the surface in either Lagoon 2 or 3. Sludge produced by a lime treatment of spent pickle liquor constitute U.S. EPA listed Hazardous Waste, No. K063 (40 CFR Part 261.32). Liquid and sludge in the lagoons registered between 7 and 10 on pH indicator strips. At the surface, the lagoon liners appeared to be intact. No tears, holes, or abraded surfaces were evident on the exposed parts of the liners. The part of the liners containing the liquids and sludges are assumed to be intact. No effort was made to excavate soil or to check the subsurface integrity of the liners because of the potential of causing contaminant migration.
